Section I

EARTHQUAKE DAMAGE

INTENSITY DISTRIBUTION AND ISOSEISMAL MAP FOR
THE MORGAN HILL, CALIFORNIA, EARTHQUAKE OF APRIL 24, 1984

PERFORMANCE OF RESIDENTIAL STRUCTURES
DURING THE MORGAN HILL EARTHQUAKE OF APRIL 24, 1984

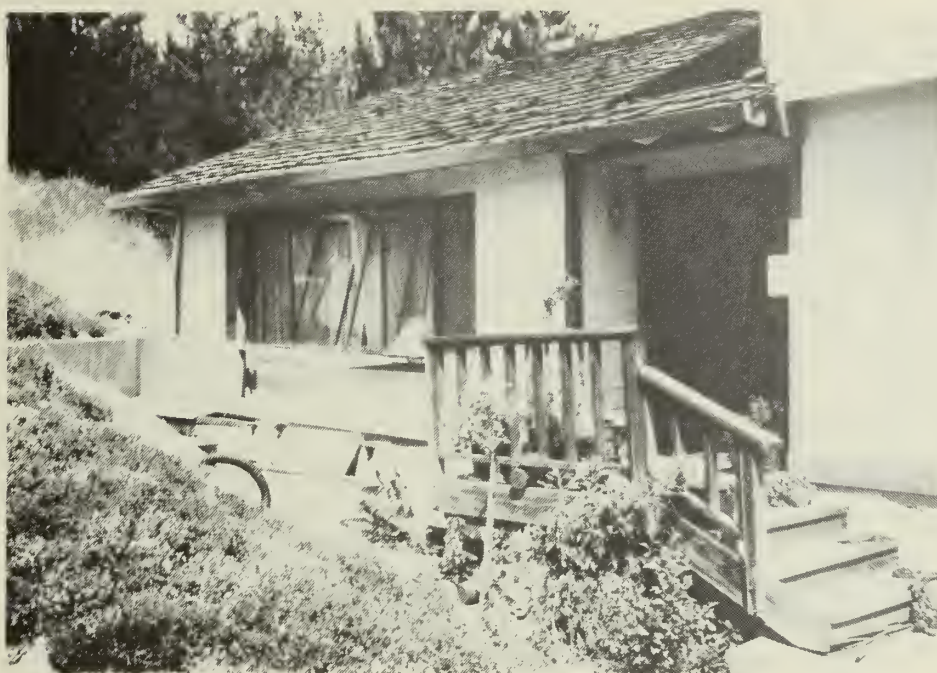
Split-level home which suffered cripple wall failure due to the use of homosote as the sheathing material.

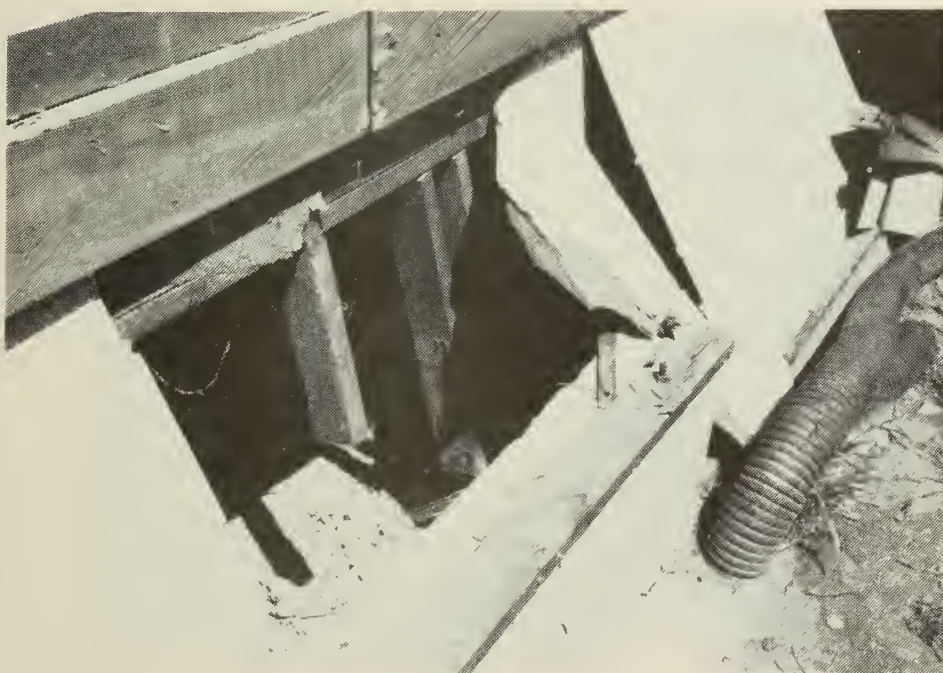
Close-up of split-level home.

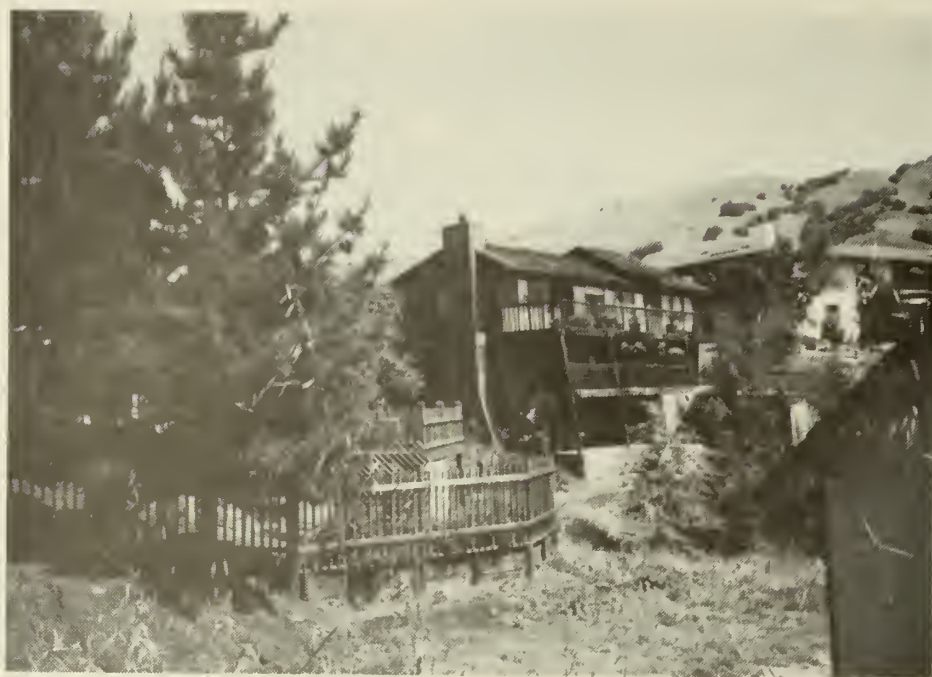
Hillside home which suffered cripple wall failure due to inadequate nailing of plywood panels.

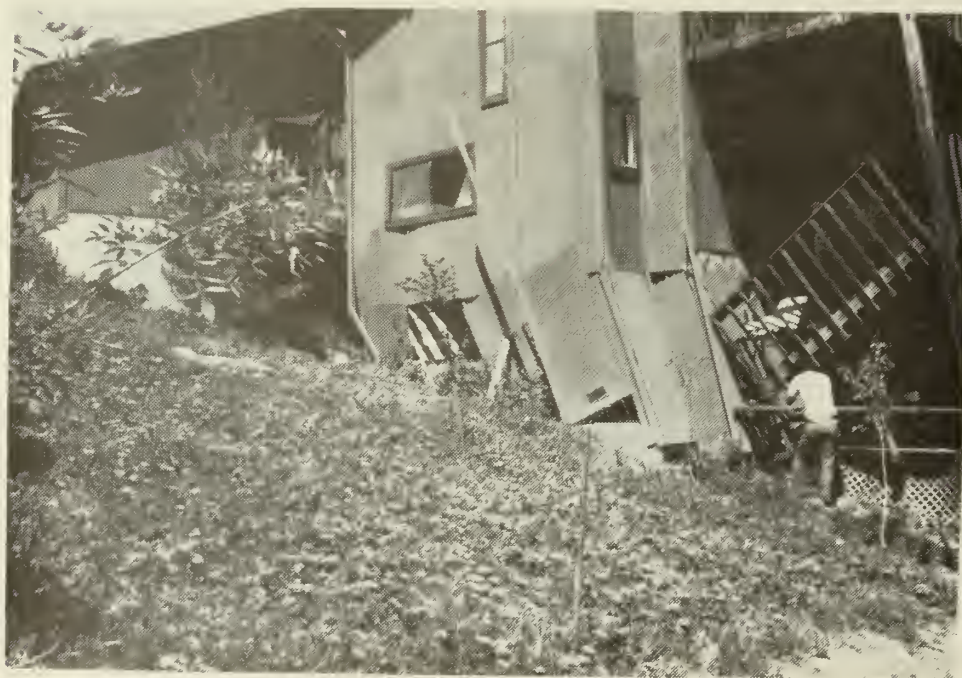
Close-up of hillside home.

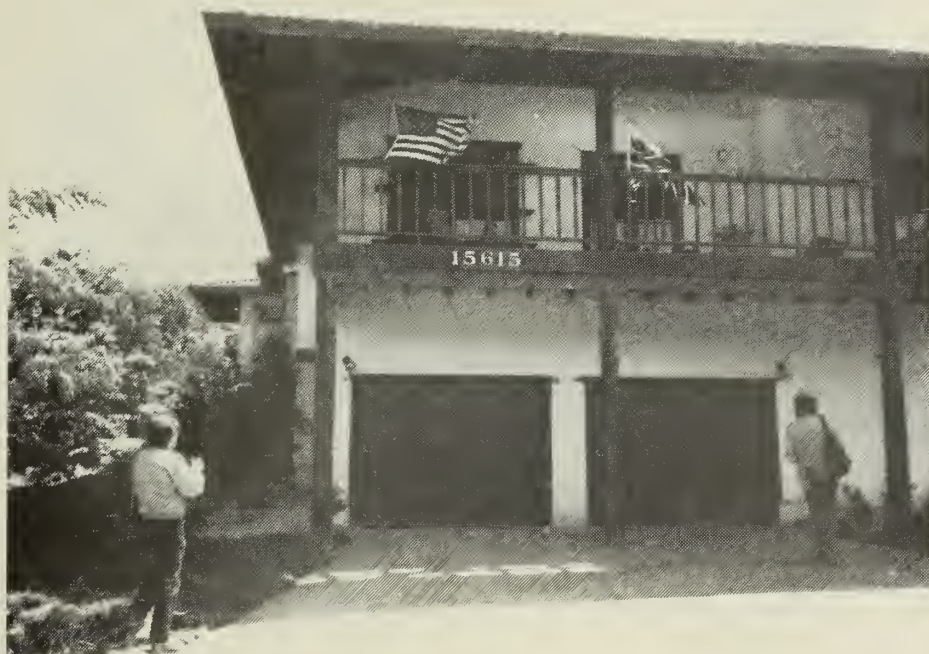
Damage to two-story house with garage on first level.

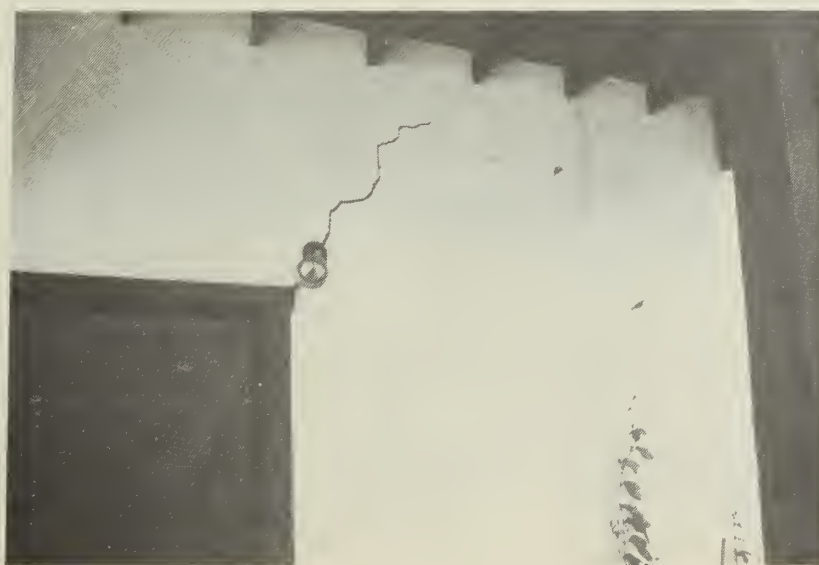
Close-up of two-story house.

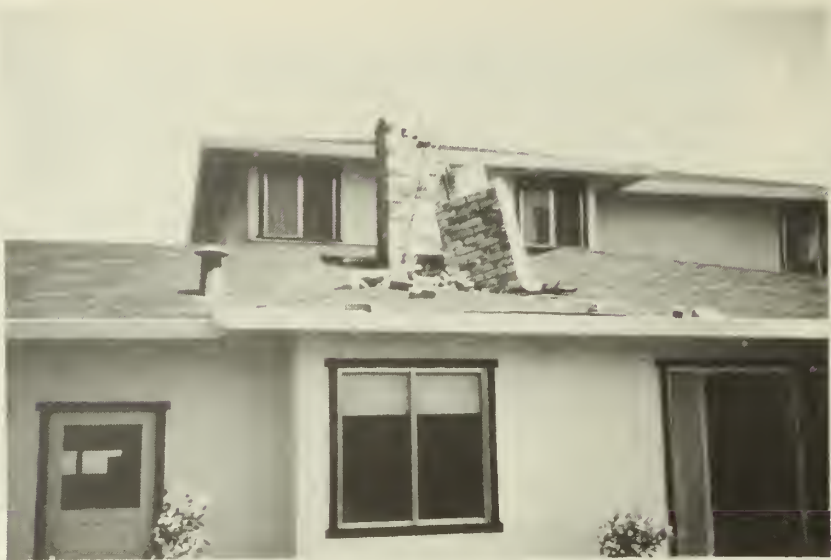
Failure of reinforced masonry chimney.

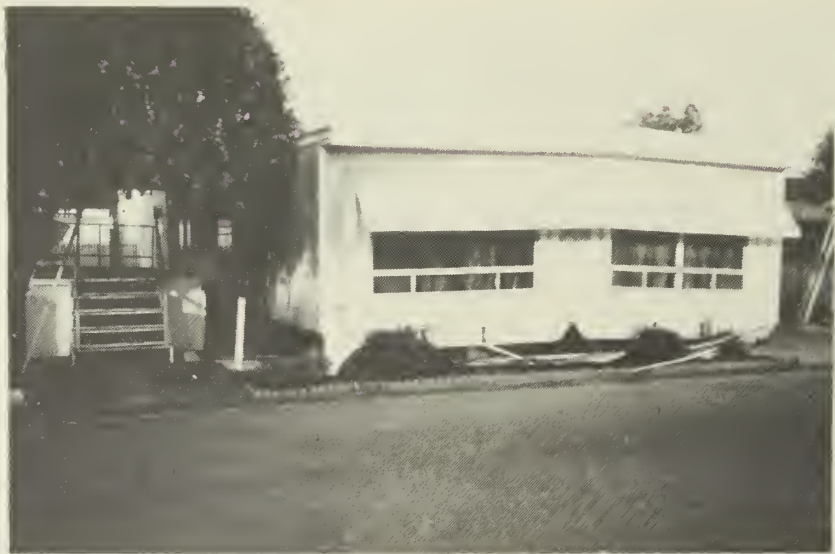
Collapse of mobile home.

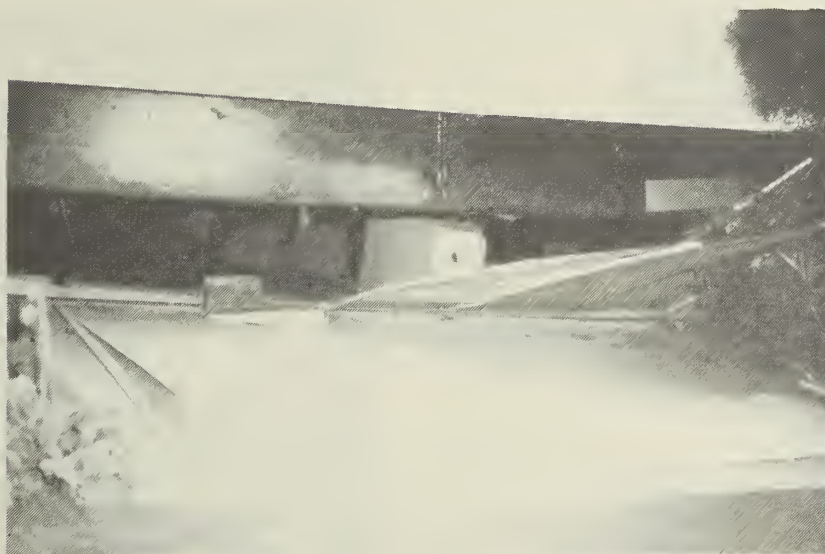
Concrete piers which had fallen caused collapse of mobile home.

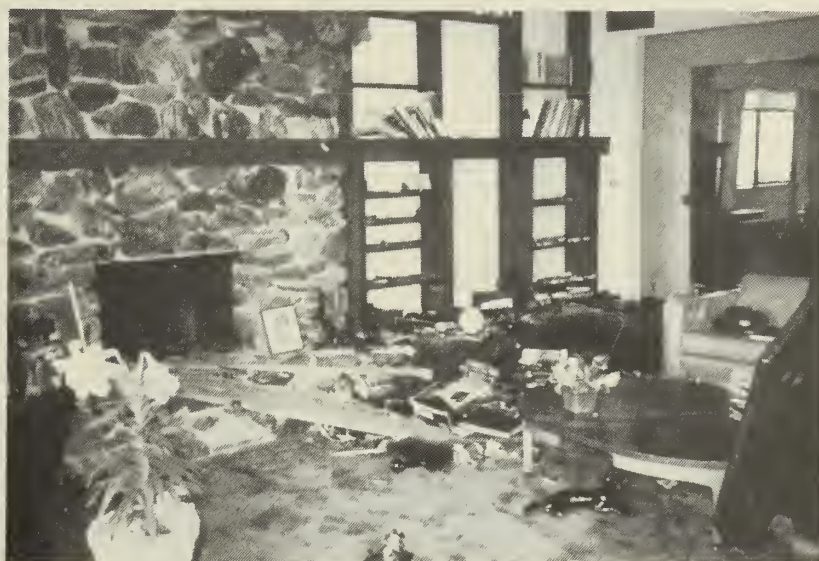
Interior damage to contents.

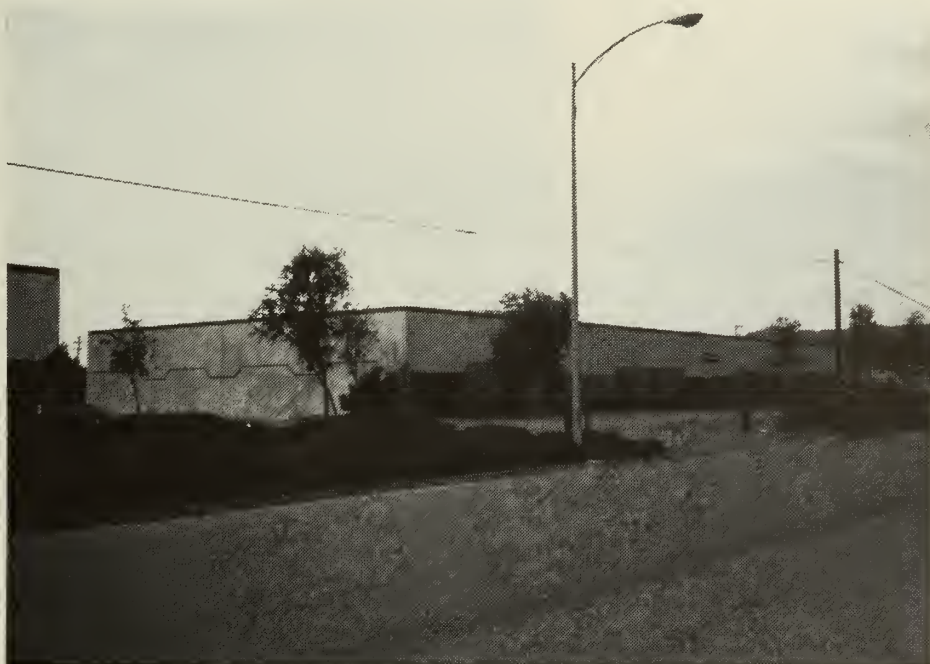
Photo 1. The Wiltron Mast Street facility in Morgan Hill shows no apparent signs of exterior damage. Nonstructural interior damage was extensive.

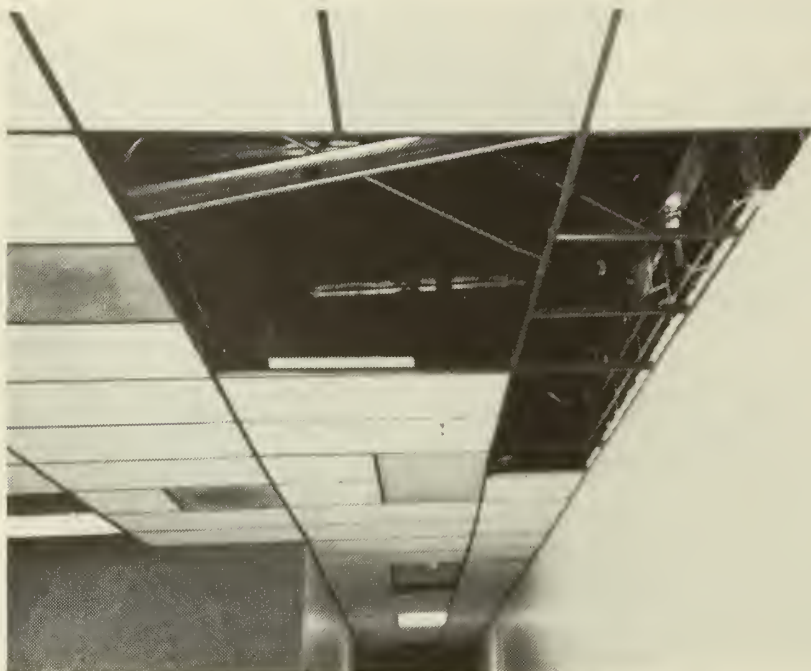
Ceiling tiles fell from the suspended ceiling at the perimeter walls (photo 3). The north-south running partition walls pulled away from the exterior tilt-up walls (photo 4). At the north side of the building, the wall separation varied from 0.5 to 1.5 inches. At the south side of the building, the partitions were crushed, resulting in approximately a 0.5 inch separation between walls. In one location, a lightweight metal stud buckled. The neoprene window glazing in some of the steel mullions popped out, probably because of the rotation of the glass in the window frame. There was some cracking in the roofing at the southwest corner of the building.

Photo 2. Many ceiling tiles fell in the Wiltron building.

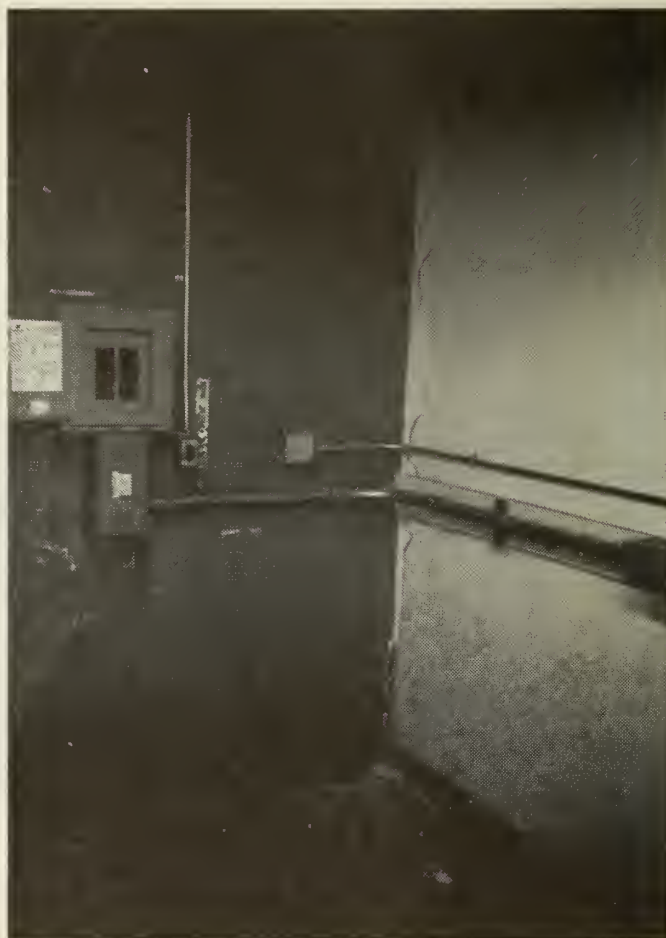
Photo 3. Most interior partitions suffered significant damage at Wiltron.

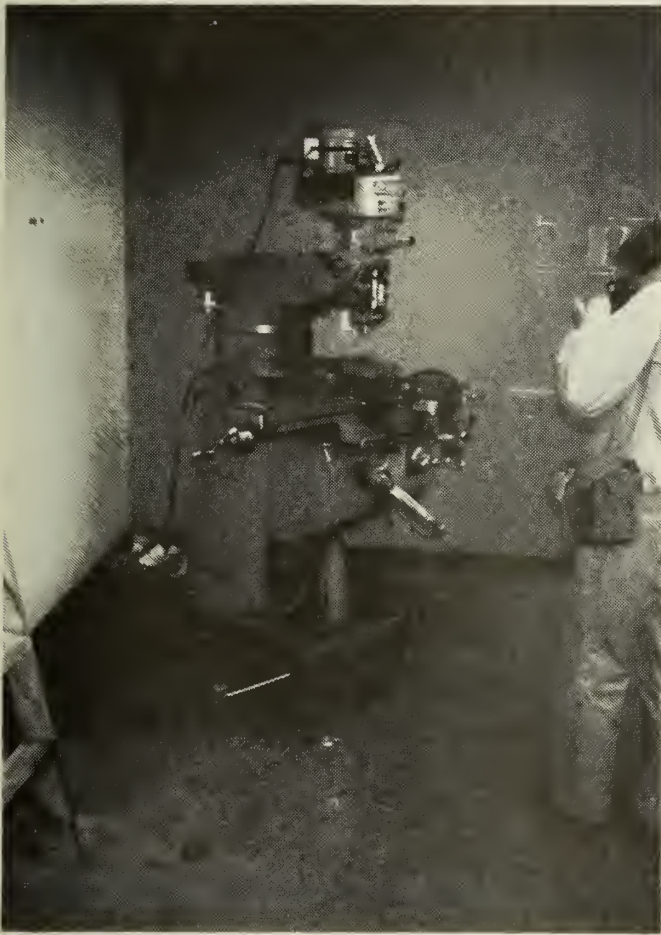
Photo 4. Shifting of heavy equipment at the Wiltron facility indicates a maximum acceleration at the site between 0.3g and 0.4g.

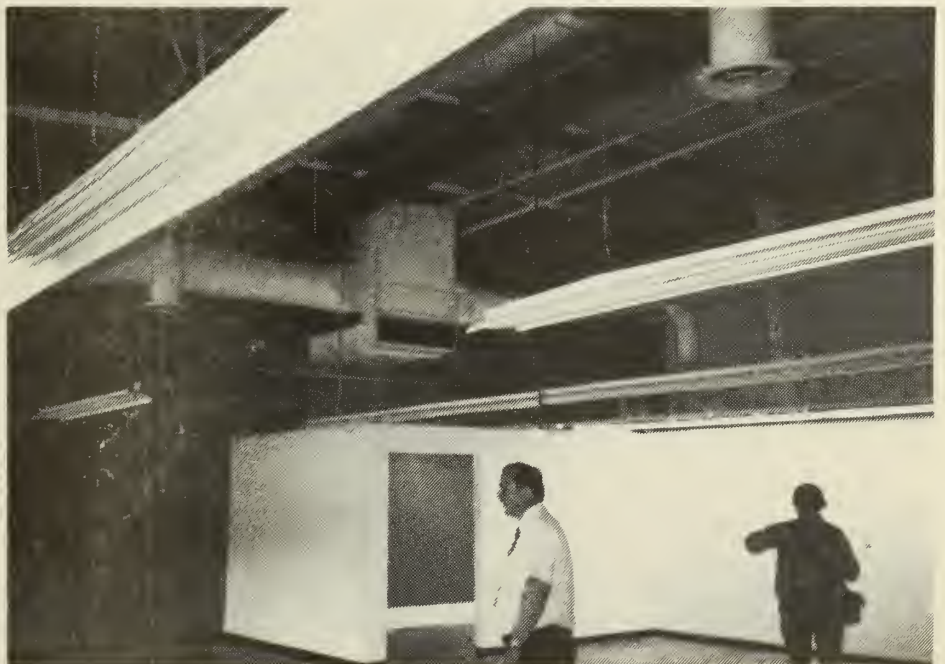
There were two circular ducting failures, and a few chain-suspended industrial light fixtures fell (photo 5). The suspended compressed-air lines showed no signs of leakage or damage. The plumbing remained intact, including the fire sprinkler piping system. Shelves in the storage area retained their contents. Solder slogged out of an automatic solderer, splashing onto the nearby walls, ceiling, and floor.

Photo 5. A few chain-suspended industrial light fixtures fell at Wiltron. There were also some circular ducting failures in this area.

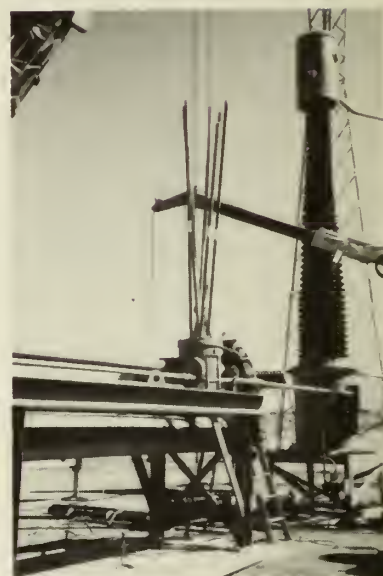
Figure 6. Damaged Live Tank Circuit Breaker.

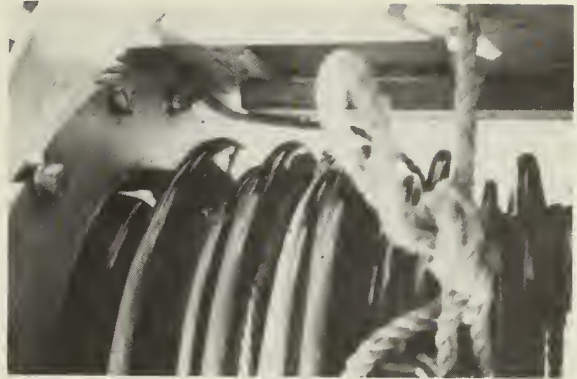
Figure 8. Cracked Interrupter Head Support Column.

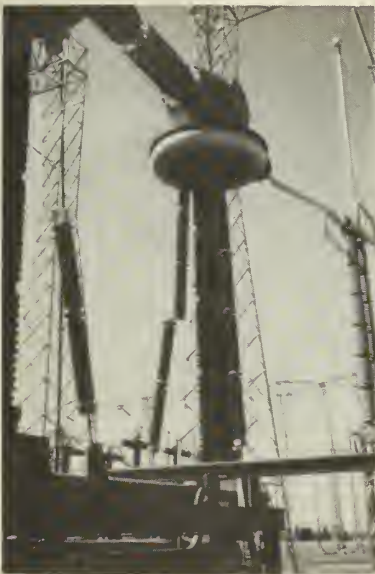
Figure 9. Two Damaged Stays.

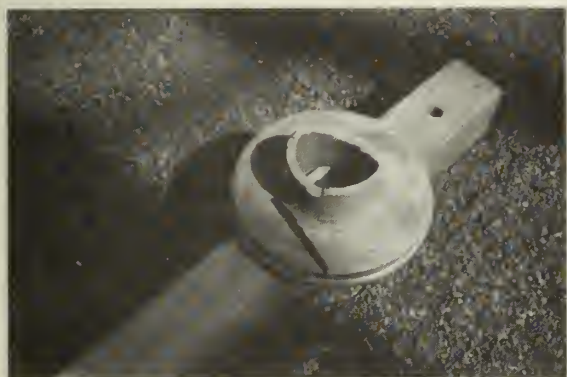
Figure 15. Bottom Half of Damaged Head Support.

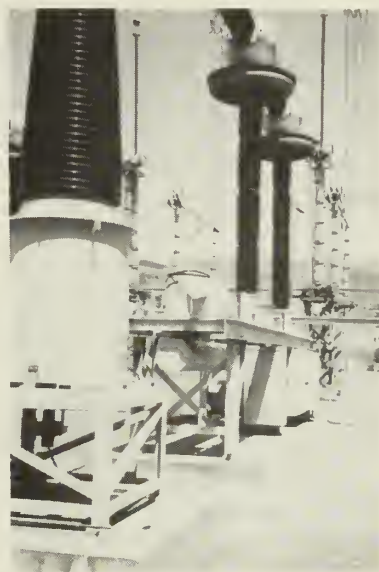
Figure 16. Damaged Circuit Breaker at Metcalf.

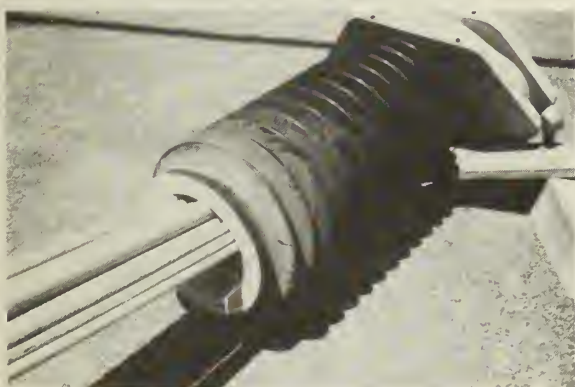
Figure 17. Remains of Column Showing Internal Tendons.

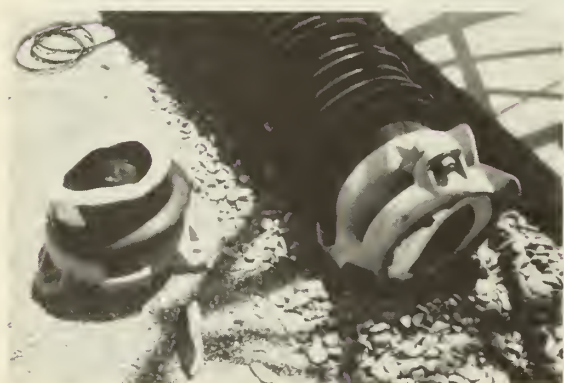
Figure 20. Fractured Lower End of Lightning Arrester.

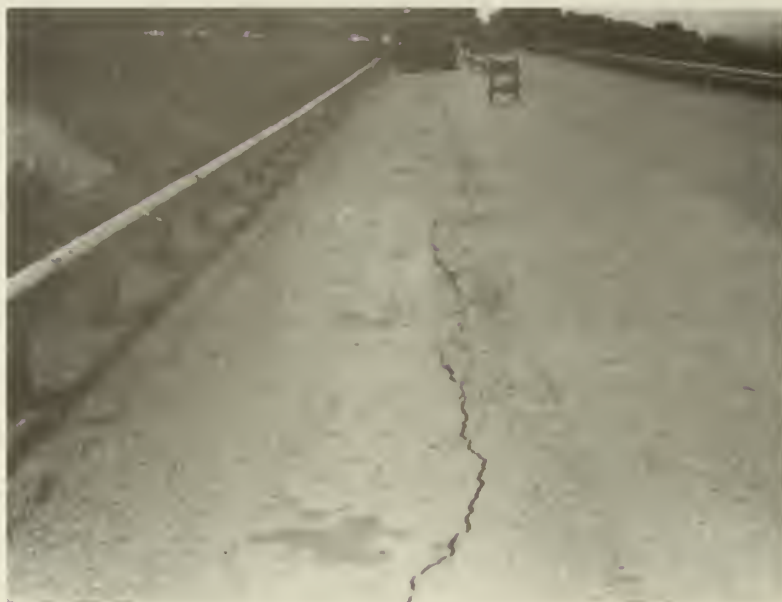
Leroy Anderson Dam-cracking on the crest road.

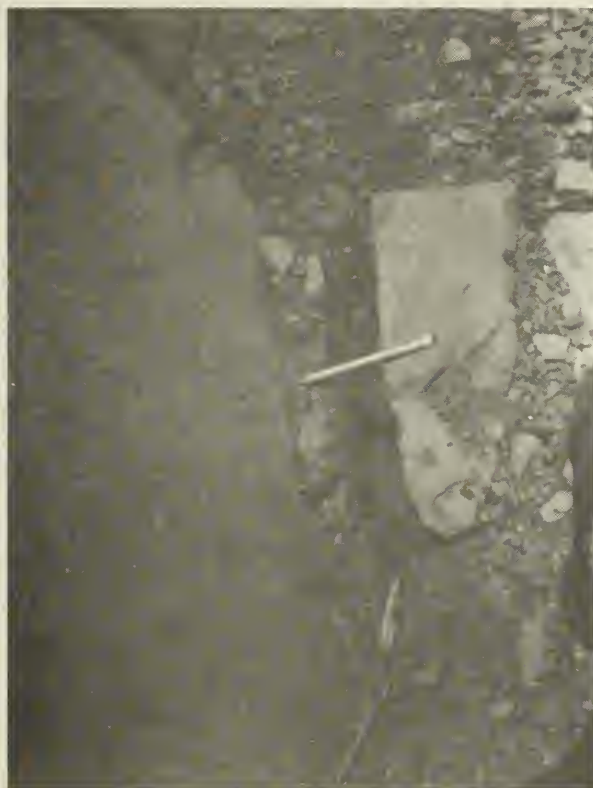
Coyote Dam-cracking on the upstream slope.

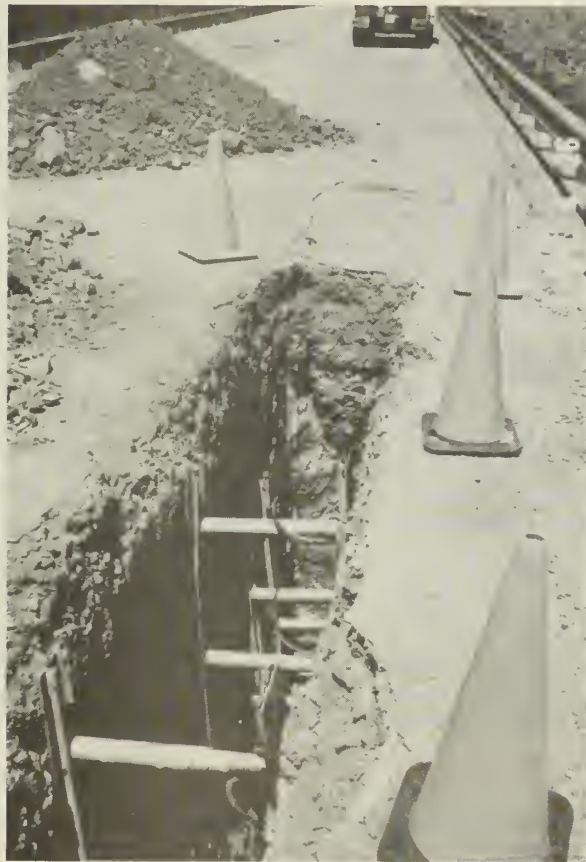
Figure 3. EXPLORATION TRENCH AND CREST PAVEMENT CRACK NEAR UPSTREAM EDGE OF ANDERSON DAM

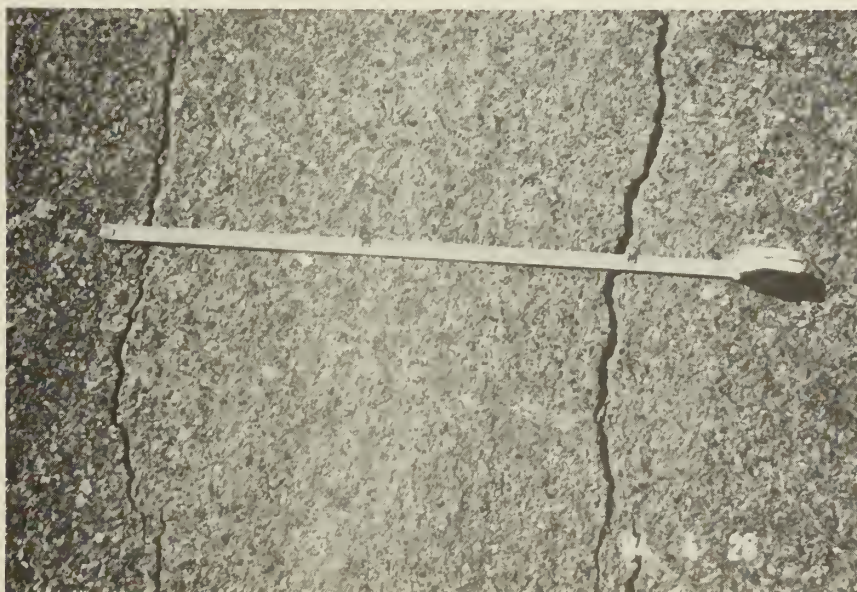
Figure 4. DETAIL OF PAIRED CRACK SYSTEM IN CREST PAVEMENT, ANDERSON DAM. CRACKS ARE ABOUT 21 INCHES APART AT MEASURING TAPE.

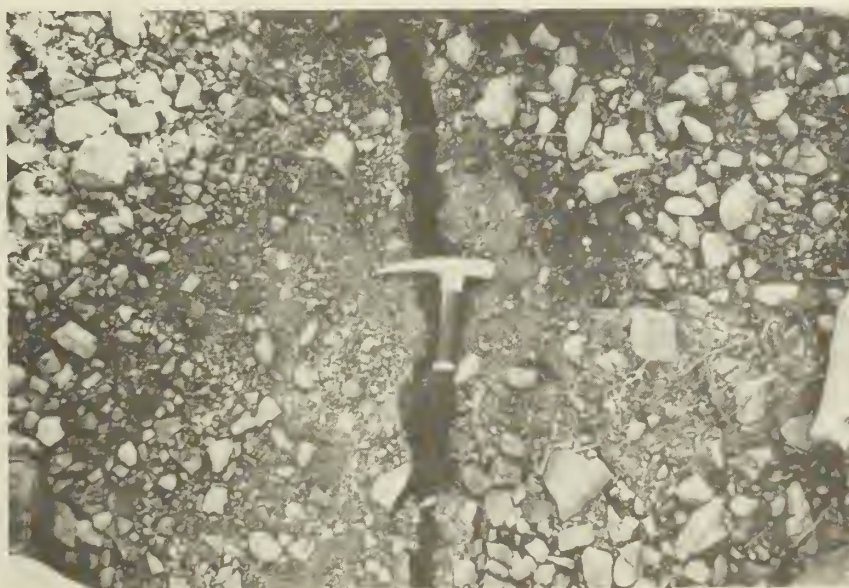
Figure 8. DETAIL OF CRACK IN INFILLING SEDIMENT BETWEEN SHELL BOULDERS, UPSTREAM FACE OF COYOTE DAM.

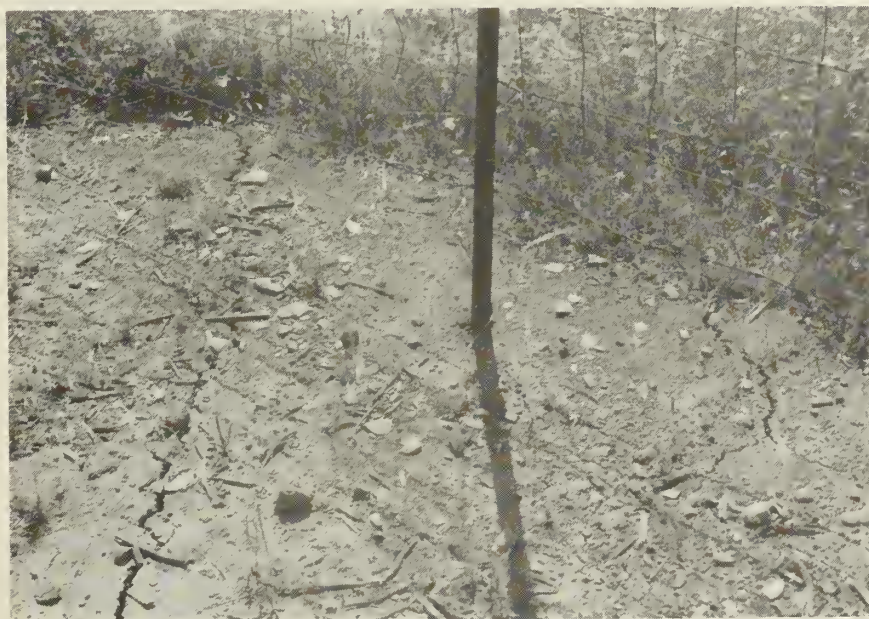
Photo 2 - En Echelon Cracks in the Ground about 15 Feet Southwest of the Instrument

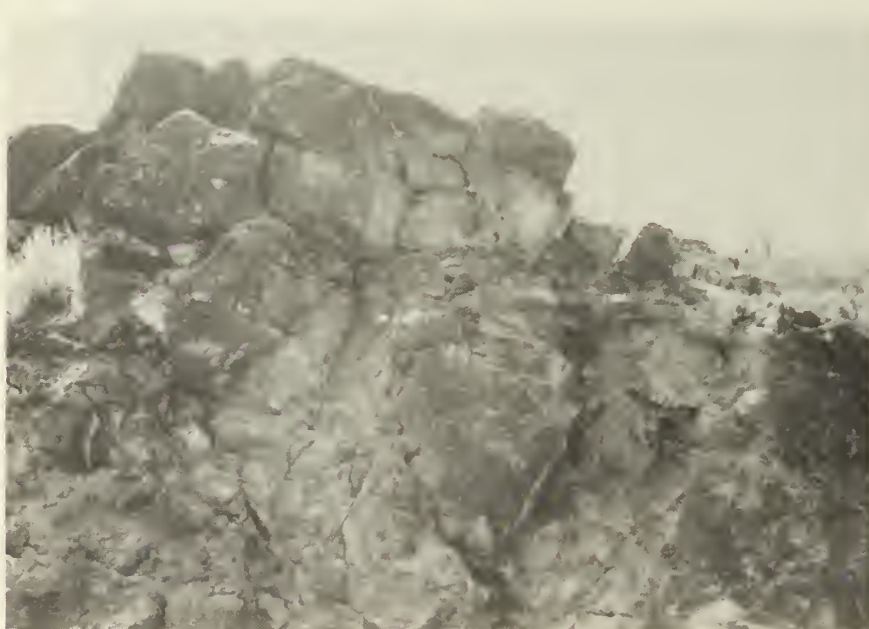
Photo 4 - Close-Up View West of Rock Fall Location and the Fractured Rock

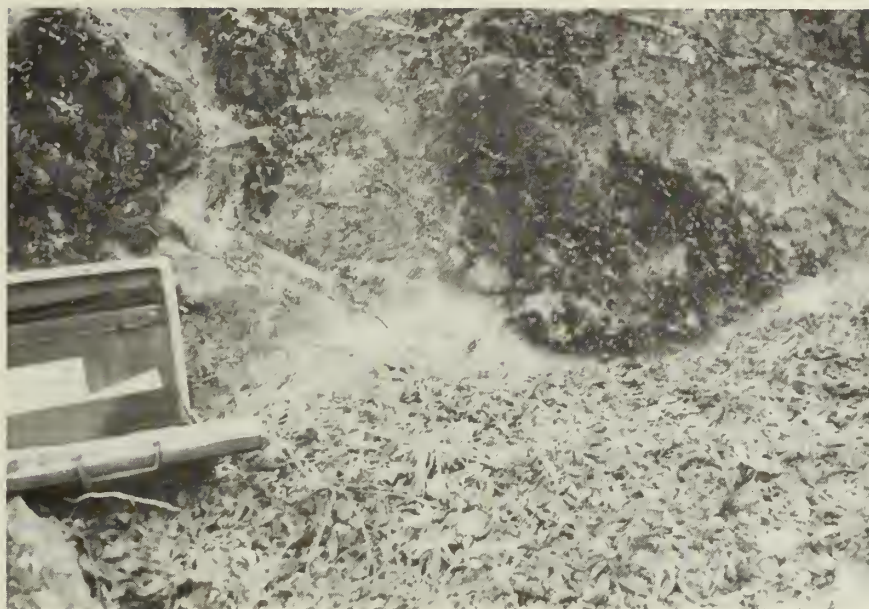
Photo 5 - Close-Up View East of the West Side of the Rock Showing a Fresh Crack and Relative Movement Between the Ground and the Rock

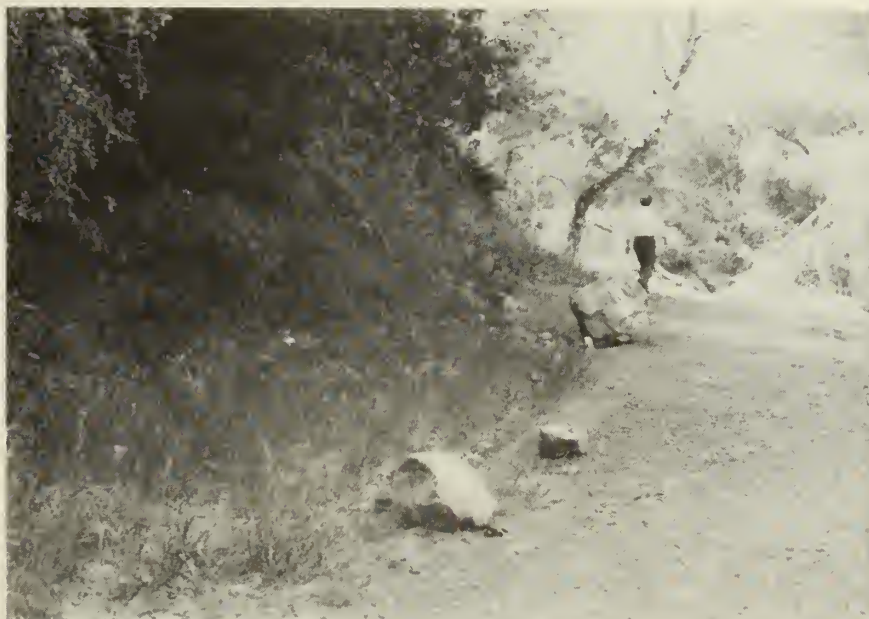
Photo 6 - Northwest View of a Location Northwest of the Dam Where Boulders Rolled from the Slope to the Shoulder of the Road

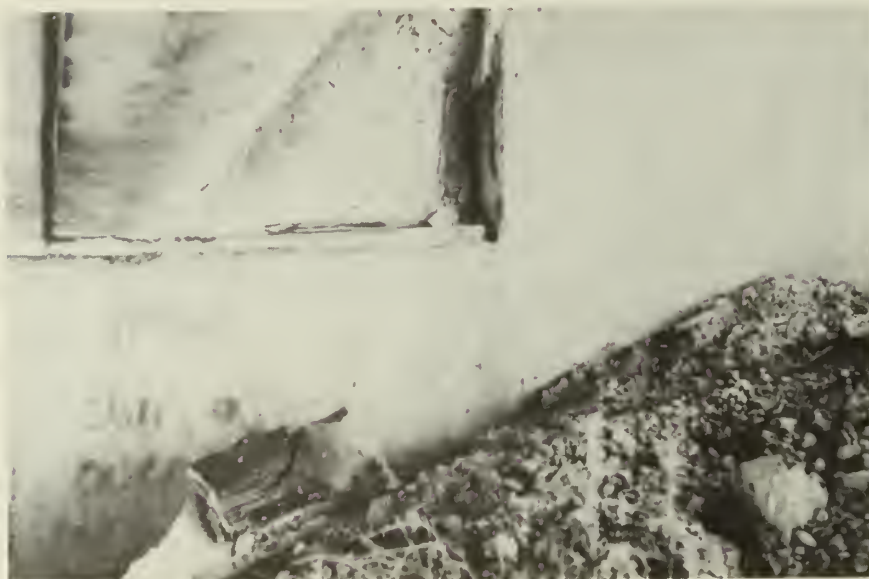
PHOTO 9 Coyote Creek Bridge, Br. No. 37-349L
End diaphragm spall at south abutment.

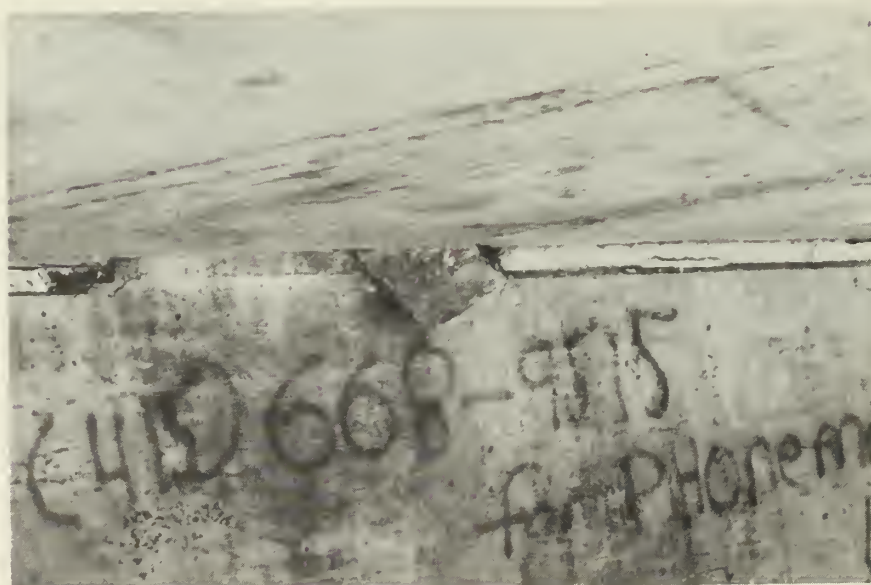
PHOTO 10 Coyote Creek Bridge, Br. No. 37-349L
Interior key spall at south abutment.

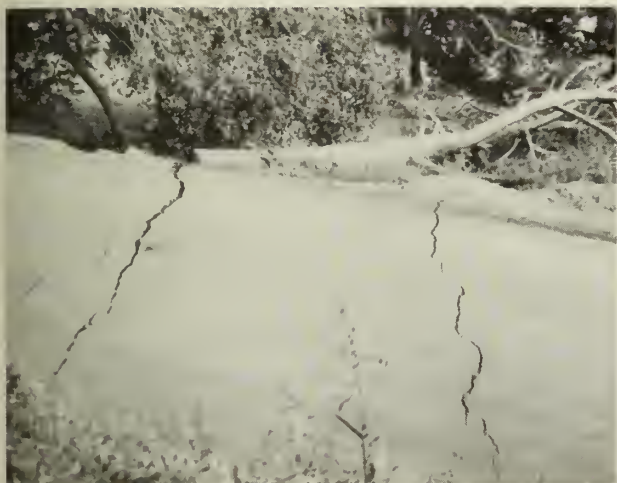
Photo 1. Two well-defined sets of north-west-trending cracks in East Dunne Ave. 0.4 km northwest of Cochrane Bridge (Locality 2, Figure 1). Right-lateral slip of 6 cm and 2.5 cm was measured on left and right sets, which are parts of a 30 m-wide zone of cracks with cumulative offset of about 16 cm. Although within a landslide, the cracks are believed to be due mainly to faulting.

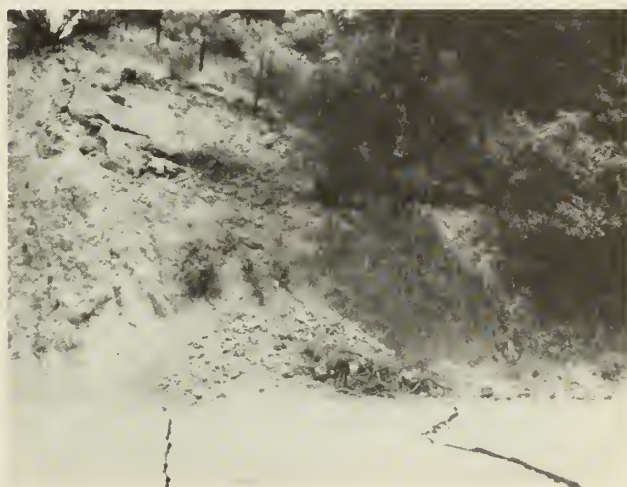
Photo 2. View to east of two N75-85°W-trending cracks in East Dunne Avenue 0.4 km west of Cochrane Bridge (Locality 3, Figure 1). Left and right cracks show 12 and 8 cm of right-lateral offset, respectively. The crack zone extends through serpentinite and colluvium in the road cut to a small spur.

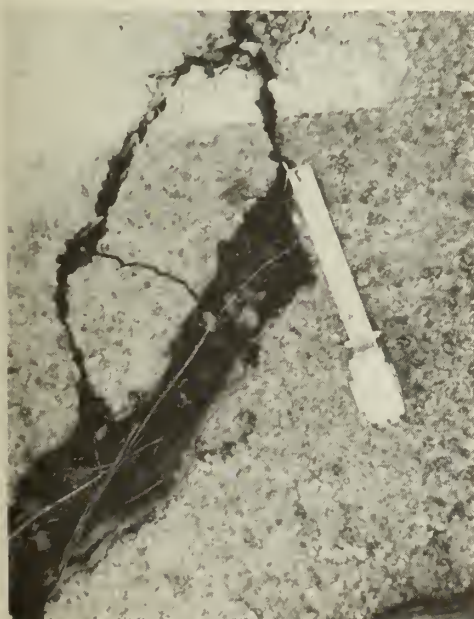
Photo 3. Detail of a portion of the right crack shown in Photo 2. Note rhombic extension of 8 cm. White line was painted to monitor possible afterslip, which was obscured as late as May 26.

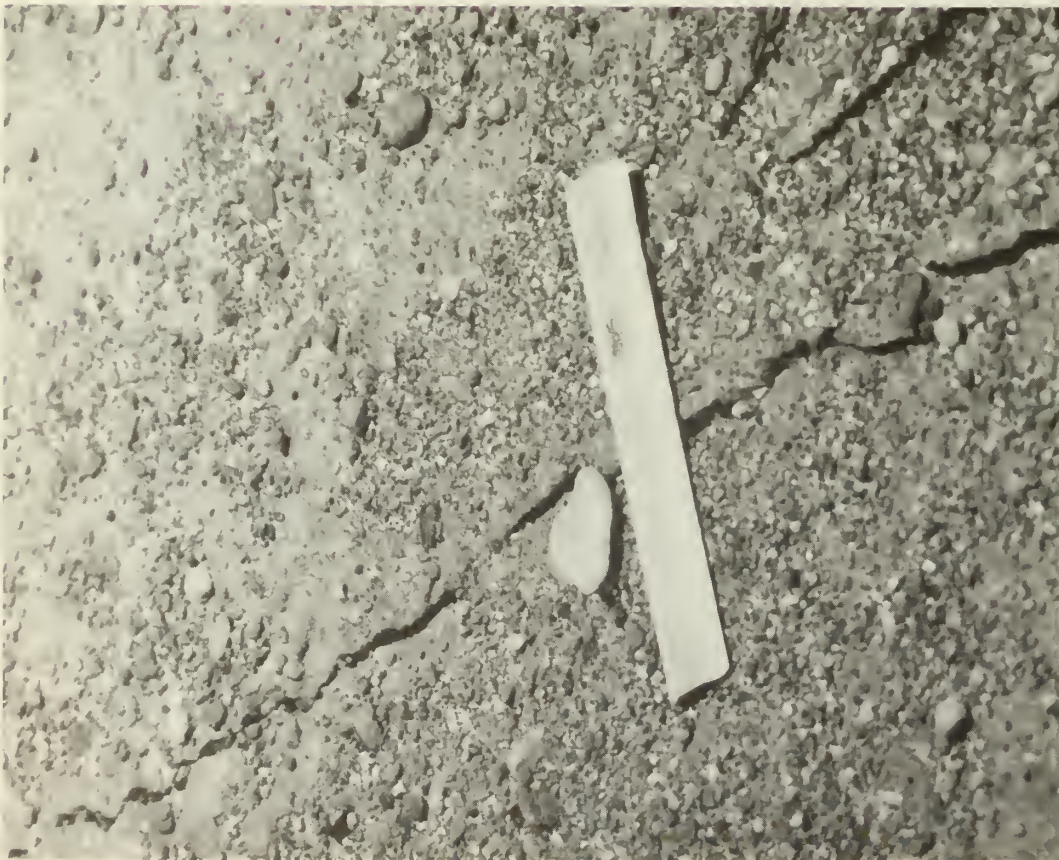
Figure 5. Close-up of fresh crack 1 m long and 0.5 cm at widest opening beside Shore Road. Scale is 15 cm long.
